# UPGRADING POWER DISTRIBUTION EQUIPMENT – MAKING THE RIGHT CHOICES FOR RELIABLE PAPER MILL OPERATIONS

**Abstract – Most paper mills in North America were built in an era when main 15KV power distribution switchgear was only available with air-break power circuit breakers and relatively low MVA interrupting ratings. As mill capacity grows, facilities engineers are often faced with either upgrading or replacing existing main switchgear, to support required increases in interrupting ratings. This paper includes a study of two different mill sites with recent experiences in upgrading power distribution equipment by replacing vintage air-break circuit breakers with new vacuum circuit breakers in existing switchgear. The long-term potential benefits of both upgrade and replacement will be reviewed, including application considerations. At the end of the paper is an analysis of the total installed cost and impact on mill profitability by upgrading existing switchgear, versus replacement with new equipment.**

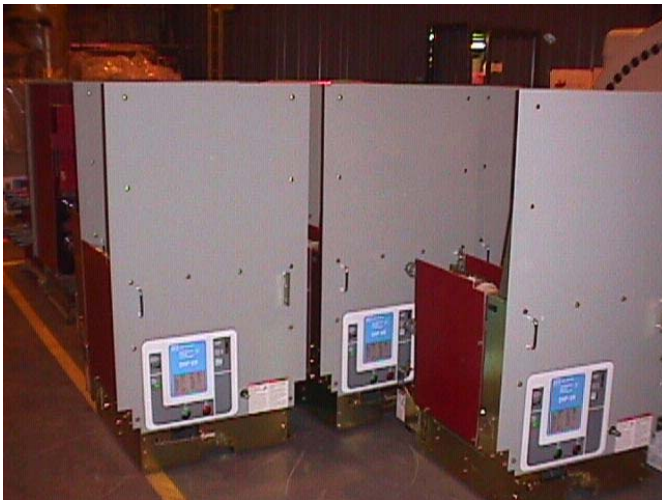
Fig. 2: Replacement breakers are positioned in staging area before scheduled upgrade.

1) *Before The Mill Shutdown:* A comprehensive upgrade plan was written by the project team and approved by mill engineering management. All work that could be performed in advance of the shutdown was scheduled and accomplished. This included receiving the 19 new vacuum circuit breakers and storing them in a designated staging area as shown in Fig. 2. Fortunately, the “Bus A” switchgear was in a large equipment room that housed the 15kV distribution along with three steam turbine-generators. There was room for all of the new breakers close to the existing switchgear. The manufacturer’s service team completed a thorough checkout and test of each breaker in preparation for the scheduled shutdown. Tests included visual inspection for shipping damage, vacuum bottle contact wipe, travel and vacuum seal check, latch and control switch check, adjustments, lubrication, electrical operation, auxiliary contact operation and insulation integrity.

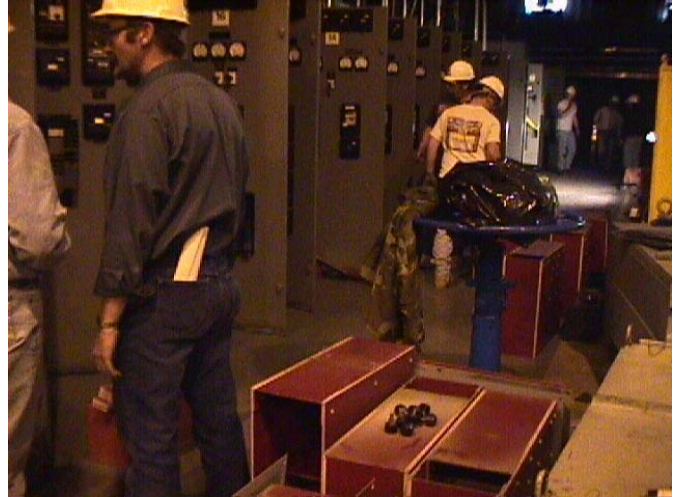
Fig. 3: During the scheduled 14 hour shutdown, a total of 2 engineers and 10 technicians from the manufacturer’s engineering services organization were deployed for the upgrade.

2) *During The Mill Shutdown:* During the scheduled outage, a total of two engineers and 10 technicians were on site to perform the work. The first 4-5 hours of the scheduled 14-hour outage were used for implementation of the standard IP lock-out/tag-out procedures. This work was accomplished by mill electricians and was completed on schedule. The switchgear upgrade team was then deployed to upgrade the existing “Bus A” switchgear as shown in Fig. 3.

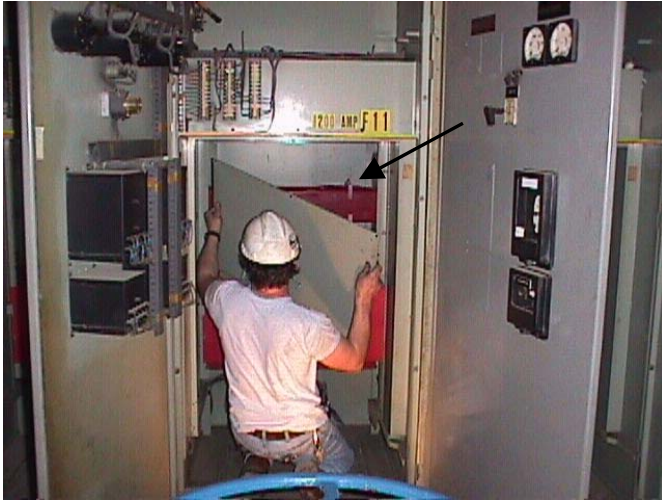
Fig. 4: A service engineer installs the main bus compartment cover plate after new bus bracing to increase interrupting rating to 1000MVA has been installed (arrow shows new bracing added in the field).

After the new bracing and main bus were installed, the technicians closed each compartment by replacing the cover plate as shown in Fig. 4. No cell modifications were required, since the replacement breakers were matched to shop order numbers from the original switchgear. This assured that all primary stabs and secondary connections were identical to the original equipment installed in 1965. Cubicle “code plates” were installed to assure that a 1200 ampere breaker could not be racked into a 2000 ampere breaker cell. With the main bus still de-energized, each breaker was again tested with the original relays, and all relay setting were checked and verified.

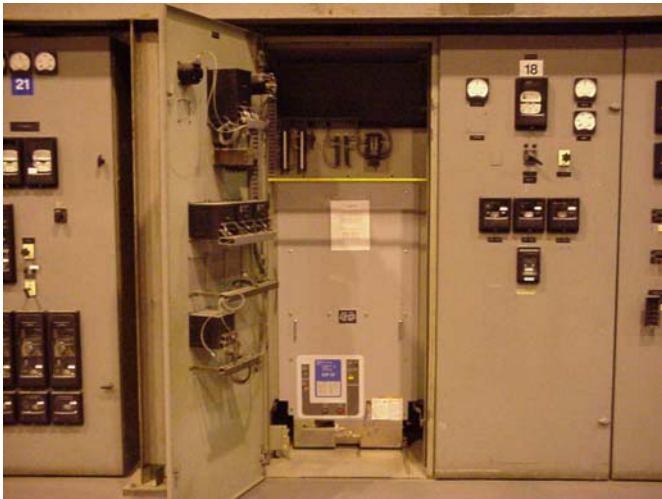
Fig. 5: Photo of the completed installation of a new replacement breaker in the upgraded "Bus A" switchgear. Original control and power wiring as well as protective relays were inspected, tested and re-commissioned.

A picture of an upgraded cubicle is shown in Fig. 5. Interestingly enough, part of the upgrade agreement with the service contractor included providing a credit for return of the old air-magnetic breakers. The mill didn't want the old breakers, and they had some salvage value in the used parts market.

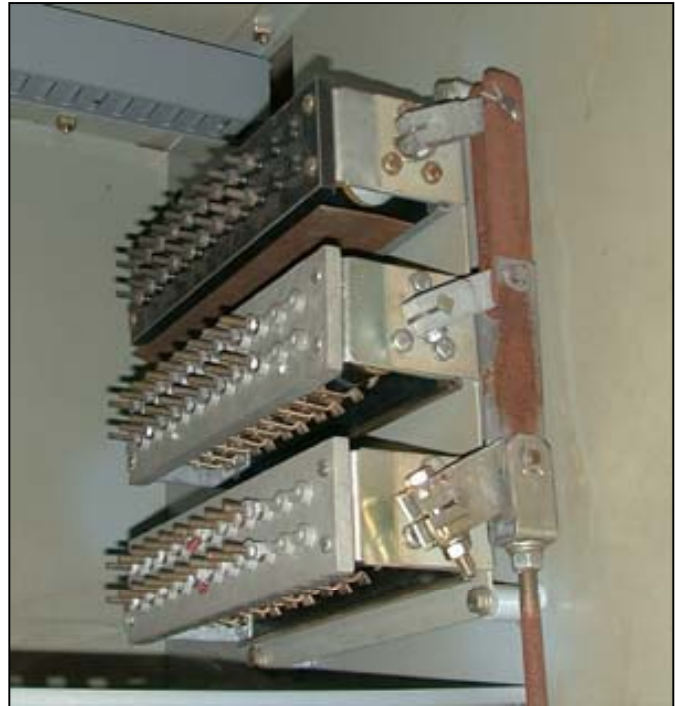
Fig. 6: Three Mechanism Operated Contacts (MOCs) mounted in a cell with mechanical (Drive Rod) linkage to the breaker operating mechanism.

Air magnetic breakers have a very long contact stroke with a heavy contact mass. The result is a slow response time, often up to 100 milliseconds (ms) to close and 55ms to open. Conversely, the vacuum breaker has a much smaller contact stroke with lighter moving contact mass. The result is a much faster response time, often less than 25ms to close and 15ms to open. The breaker mechanism linkage to the MOC operator arm is via a pantograph, which allows the breaker to operate the MOC in both the connected and test positions and to be released from the MOC linkage when the

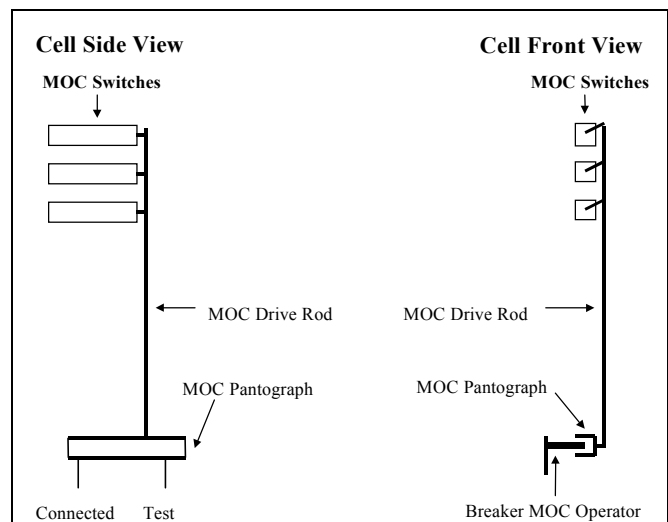
Fig. 7: Functional Operation of Mechanism Operated Cell Switch

breaker is in the disconnect position or removed. A diagram showing the operation of the MOC is shown in Fig. 7.

When the vacuum breaker mechanism attempts to operate the mechanical linkage of the MOC from the original cell, it does this at 4 times the velocity and 16 times the kinetic energy of the air-magnetic breaker mechanism. The increased mechanism travel speed results in pantograph over-travel and rebound which can cause significant problems. In most conditions, this will result in the MOC contacts bouncing, giving false indication of breaker position during open or close

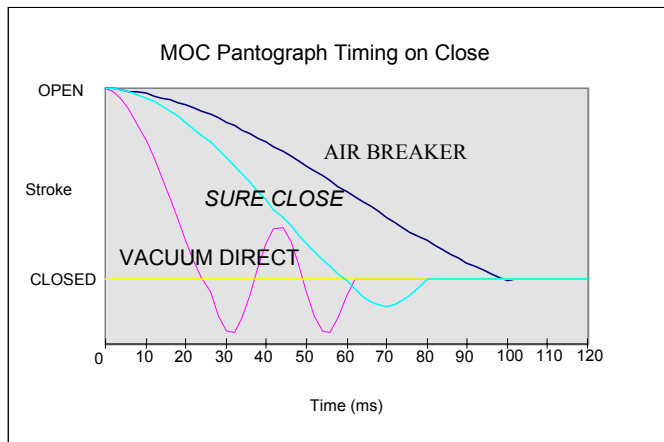
Fig. 8: Motor Operated Cell Switch Pantograph Timing for Original Air Breaker, New Vacuum Breaker and Vacuum Breaker with Sure-Close Operator.

To remedy this potential problem, a MOC interface that effectively decouples the breaker and MOC switch operation can be used. This "sure-close" operator is a stored energy device that allows the MOC to open and close independent of the breaker mechanism. Fig. 8 shows the MOC switch close transition for the original air magnetic breaker, the vacuum breaker without the decoupled interface device and the vacuum breaker with the stored energy "sure-close" device. The end result is reliable, safe operation with little or no MOC switch over-travel and no chance for a breaker stall condition. Any vacuum retrofit or replacement breaker applied in an existing air-magnetic cell with a MOC switch should include a provision to resolve this inherent mechanism response time issue.
