## Teamwork, tools and techniques: How one plant brought thermography in house

### Application Note

### Testing Functions Case Study

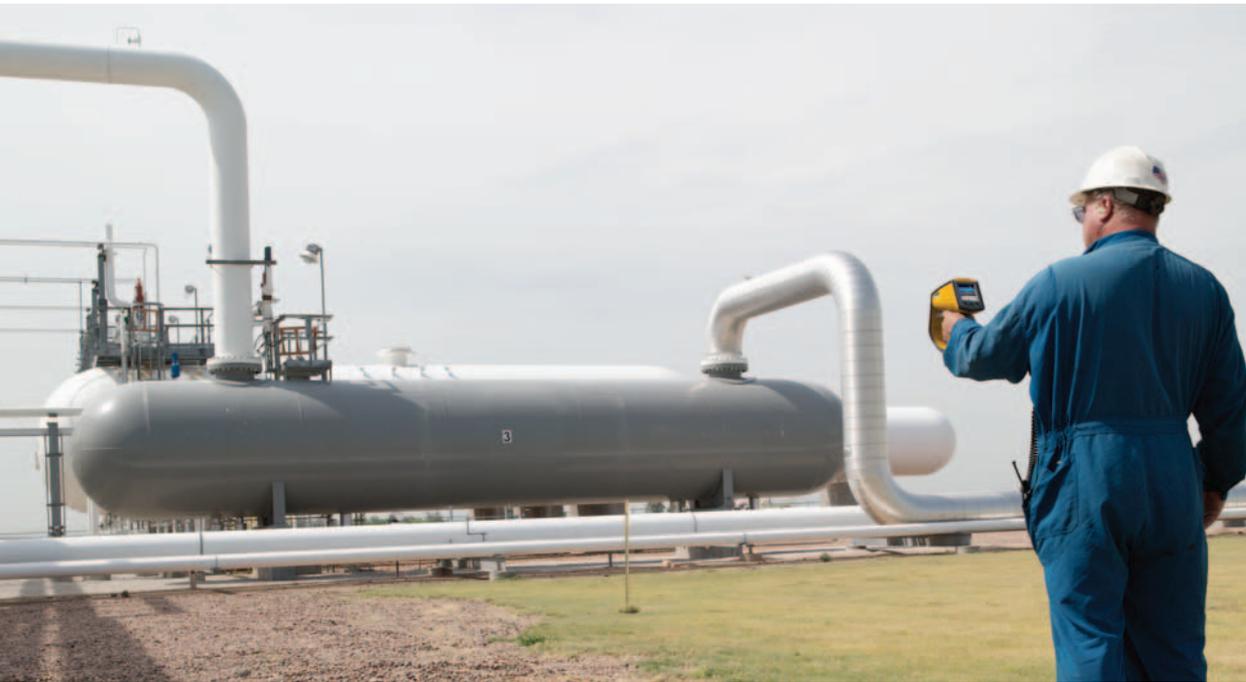
Thermal images of this sludge catcher vessel revealed the line between unrefined natural gas and heated sludge, saving the plant from a major shutdown required for manual verification.

Electrical components are not the only thing Ungles monitors at the plant. One example is the sludge catcher, the big vessel that collects waste from the natural gas. "At one point," says Ungles, "plant personnel weren't sure their level indicators were working correctly, which meant they weren't sure how much sludge was in the vessel. I made thermal images of this unit at the end of a hot day when the vessel had begun

to cool. The image revealed the line between the heated sludge and the unrefined natural gas above it in the vessel, which cooled faster. Thermography proved to be a failsafe backup to the level indicators." A vessel entry to determine the sludge depth would have required a major plant shutdown and an extremely dangerous vessel entry. "With thermal imaging," says Len Fisk, "we were able to determine this depth for a fraction of the cost of conventional methods."
